Mapping surface breakages of the 2018 Hualien earthquake by using UAS photogrammetry

Lin, Y.-S., R. Y. Chuang, J.-Y. Yen, Y.-C. Chen, Y.-T. Kuo, B.-L. Wu, S.-Y. Huang, and C.-J. Yang, 2019: Mapping surface breakages of the 2018 Hualien earthquake by using UAS photogrammetry. *Terr. Atmos. Ocean. Sci.*, 30, 351-366, doi: 10.3319/TAO.2018.12.09.02

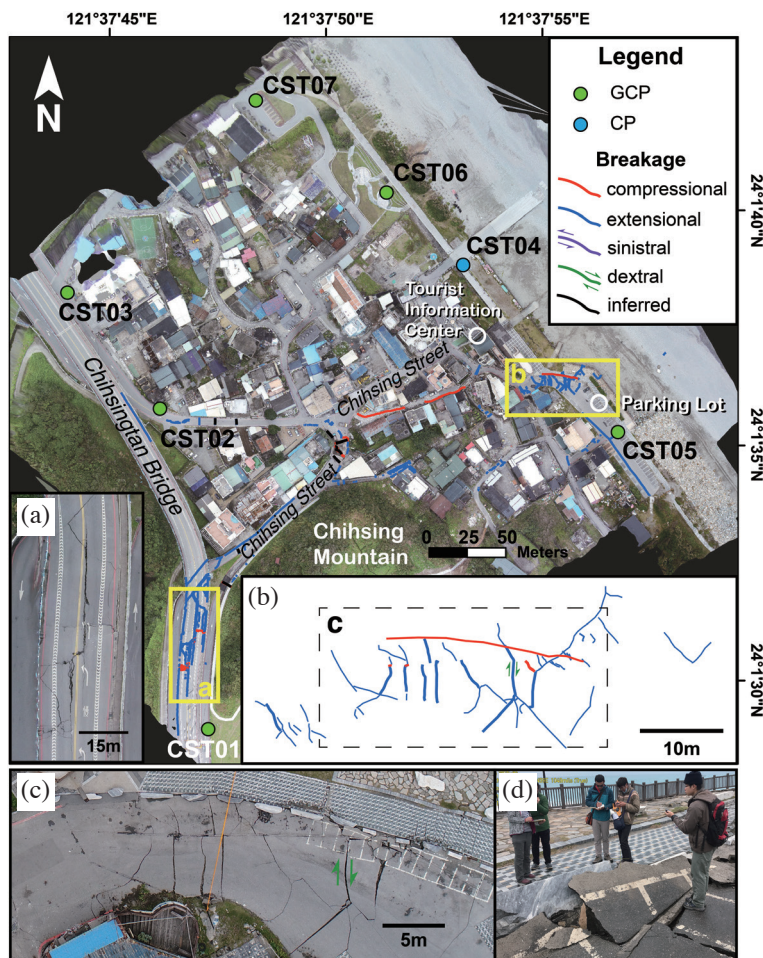
Fig. 2. Mapping of surface breakages in Chihsingtan. Green points are GPCs and blue point is CP. Red, blue, purple, green, and black line denotes compression, extension, sinistral, dextral, and inferred surface breakages, respectively. The principles for mapping breakages are described in the text. (a) Aerial image of surface breakages on the Chihsingtan Bridge. (b) Detailed mapping of surface fractures at the parking lot of the Chihsingtan Tourist Information Center. (c) Aerial image of surface fractures of (b). (d) Field photo showing the compressional feature at the parking lot [the long red line in (b)].

Chihsing Street to the south. At Chihshingtan Bridge, distributed fractures are present on the road surface (Fig. 2a).

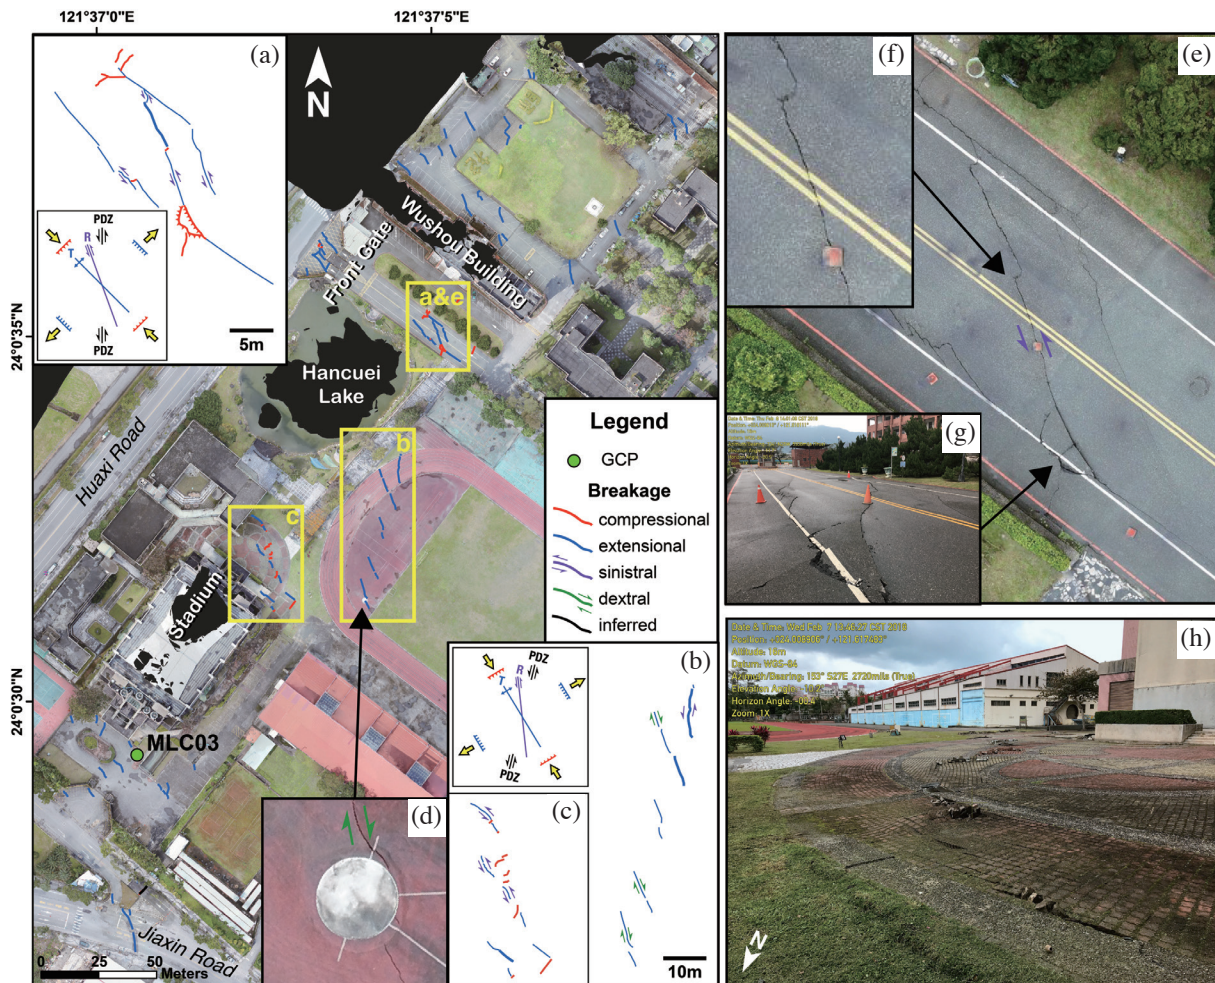
tures with some minor dextral movement (Figs. 3b and d). The first fracture can be interpreted as synthetic Riedel shear (R) and the latter are tension fractures (T), consistent with principal displacement zone (PDZ) in the direction of $\sim N20^\circ E$. The other branch broke the surface at the front gate of the campus and the brick pavement in front of the stadium (Fig. 3c). Fractures in front of the stadium are shorter and more compressional compared to those on the running tracks. The fractures here are dominated by push-up features as deformation is constrained by the shape and strength of the bricks. South of the stadium, the two fracture zones seem to join together and run across Jiaxin Road.

Fig. 3. Mapping of surface breakages in IRP, National Dong Hwa University. (a) Detailed mapping of surface fractures south of Wushou Building. Inset shows the conceptual setting of the stress field and structure orientations. (b) Detailed mapping of surface fractures on the running tracks. Inset shows the conceptual setting of the stress field and structure orientations. (c) Detailed mapping of surface fractures in front of the stadium. (d) Aerial image of fractures across the running tracks showing right lateral movement. (e) Aerial image of surface fractures south of Wushou Building. (f) Enlarged aerial image showing left-lateral movement across the solid double yellow line. (g) Field photo of (e). (h) Field photo of (c) showing compressed bricks.

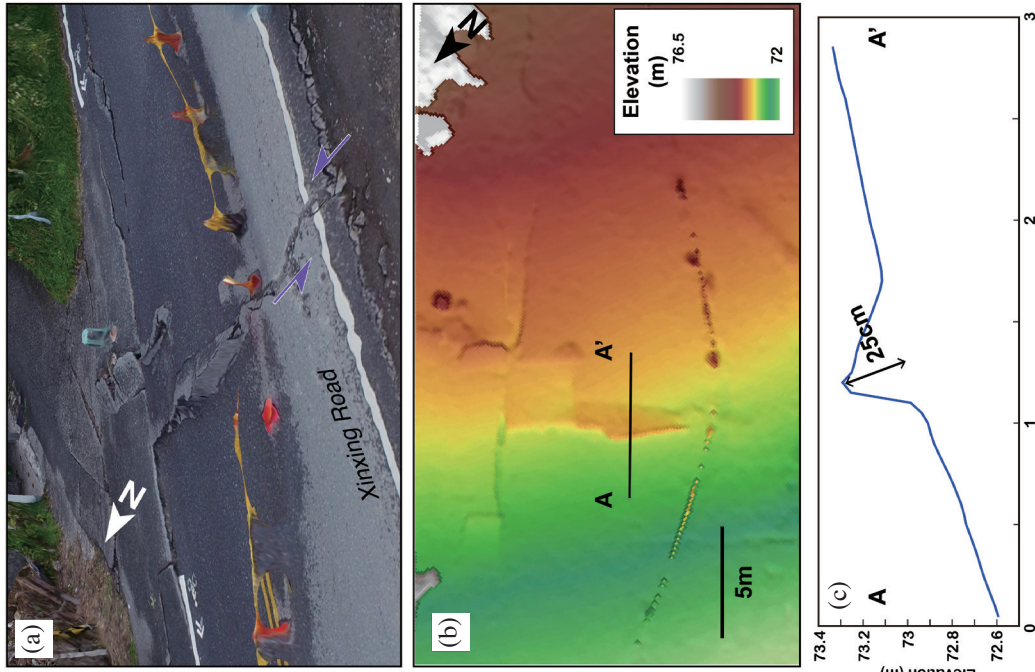
Fig. 5. 3D model of surface ruptures on XinXing Road in northern Meilun Mountain. (a) Oblique view of 3D model. (b) DSM of surface ruptures on XinXing Road. The elevation is WGS84 ellipsoidal height. (c) Topographic profile parallel to XinXing Road showing the geometry and height of the largest angular ridge.

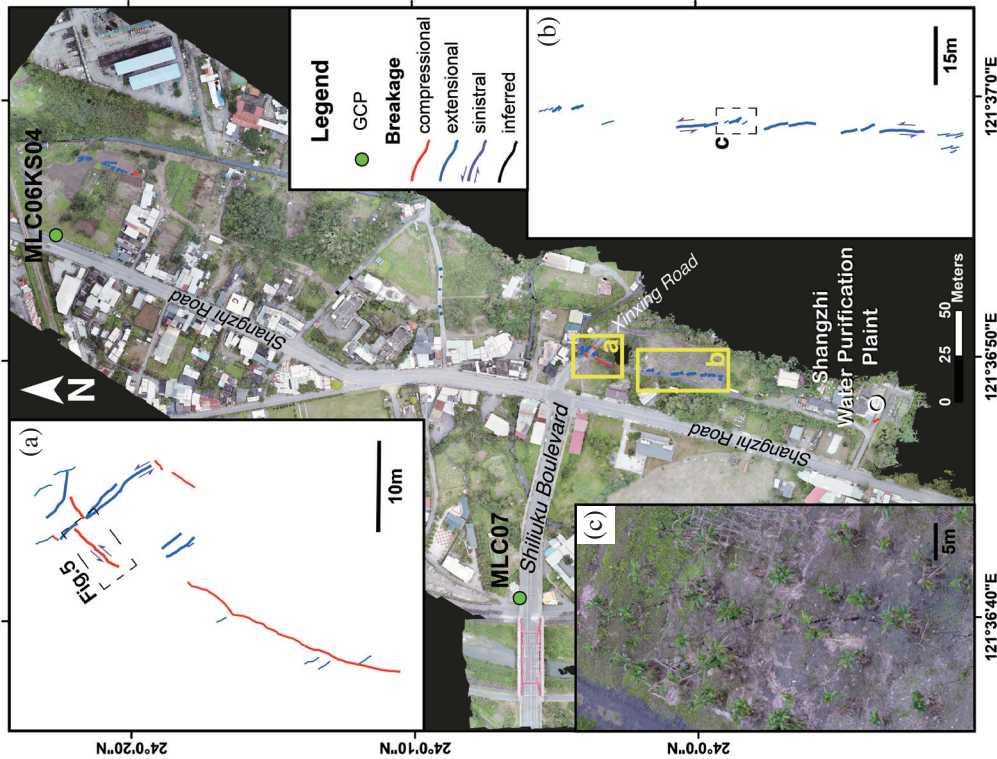
to Shangzhi Road with the strike of $N20^{\circ}E$. South of Jiaxin Road, the fault trace is within orchards and groves so we only identified few fractures (Fig. 4). On XinXing Road around the northern tip of Meilun Mountain, the rupture transects the road with sinistral movement and push-up mole tracks (Fig. 4a). In addition to orthoimages, the SfM-MVS method generates 3D models and DSMs, showing topography and surface relief. According to the 3D model (Fig. 5a), the white side line to the south is offset sinistrally and the fractures across the road shows stepovers with features of angular ridges. DSM produced by the SfM-MVS method is also helpful for identify such features (Fig. 5b). A topographic profile estimates the height of 25 cm for the largest angular ridge (Fig. 5c). To the south note that the rupture climbed up to foothills instead of ran along the western boundary of Meilun Mountain. The strike of surface breakages become N-S striking tension fissures as going uphill to a banana orchard (Figs. 4b and c). Toward south, surface ruptures seem transect the Shangzhi Water Purification Plant, causing pipeline leakage and water outage for several days after the earthquake.

Fig. 4. Mapping of surface breakages in northern Meilun Mountain. (a) Detailed mapping of surface fractures on Xingxin Road. The box shows the location of Fig. 5. (b) Detailed mapping of surface fractures on the foothills of northern Meilun Mountain. (c) Aerial image showing N-S surface fractures across the banana field.

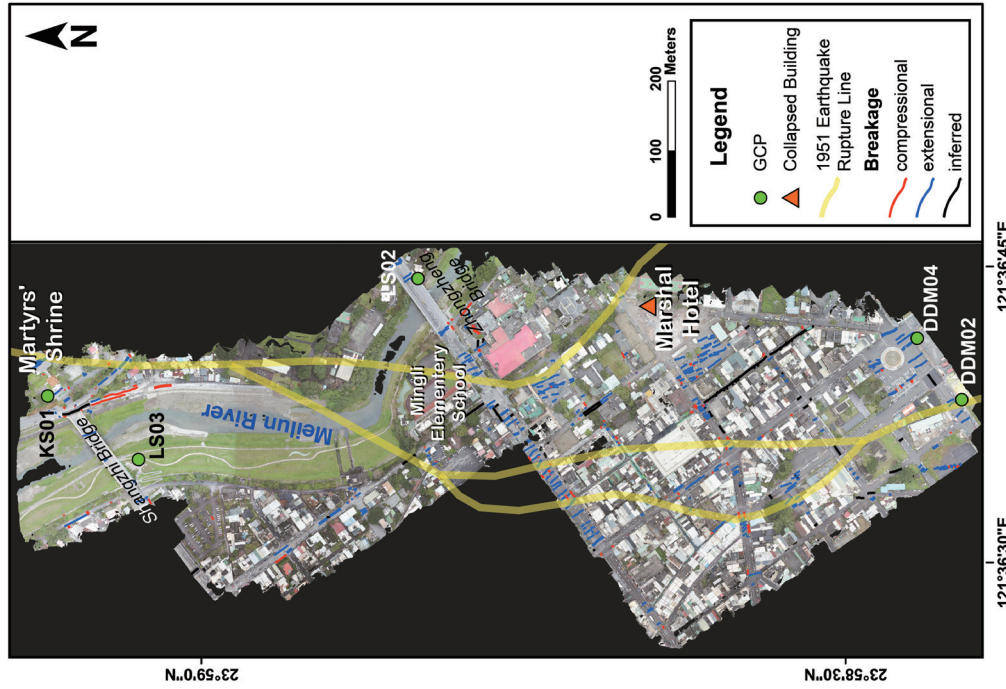
South of Meilun Mountain, surface fractures are extensively distributed across eastern downtown Hualien. Near the Martyr's shrine, fractures were present at both sides of Shangzhi Bridge (Fig. 7). The preliminary field investigations documented severe damages at the western side of

Shangzhi Bridge (CGS 2018); however, we failed to collect images at the place. Therefore, the fault trace could connect from the western edge of Meilun Mountain to the western side of Shangzhi Bridge. Further south, surface fractures seem to be restrained in between streets and open fields. Tensional shears were mapped mainly in the direction of $N35^{\circ}W$ and compression fractures generally follow the direction of $N55^{\circ}E$ (Fig. 7). Fractures at open fields like tarred fields west of the collapsed Marshal Hotel have a little bit more diverse and oblique orientations. Note that it is somewhat difficult to map surface fractures within such urban areas on the orthoimages, especially when fractures are present along the edges of buildings or under the verandas. Overall, surface fractures in eastern downtown Hualien display distributed patterns with restraints from surrounding buildings. Compared to the surface rupture lines of the October 1951 earthquake (CGS 2018), surface fractures of the 2018 Hualien earthquake in downtown Hualien City are more distributed (Fig. 7).

Fig. 7. Mapping of surface breakages in east of downtown Hualien. Light yellow lines are surface ruptures of the October 1951 earthquake modified from CGS (2018).

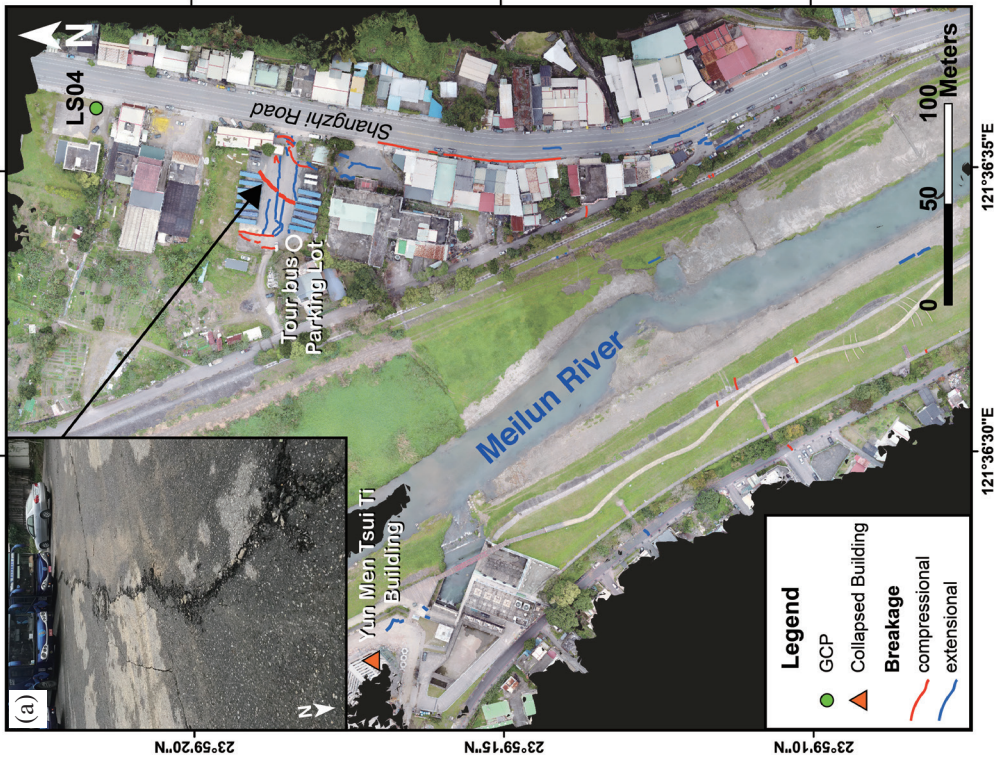
Fig. 6. Mapping of surface breakages in western Meilun Mountain. The tilted building to the left is Yun Men Tsui Ti Building, one of the four buildings collapsed during the earthquake. (a) Field photo of the damaged tour bus parking lot.

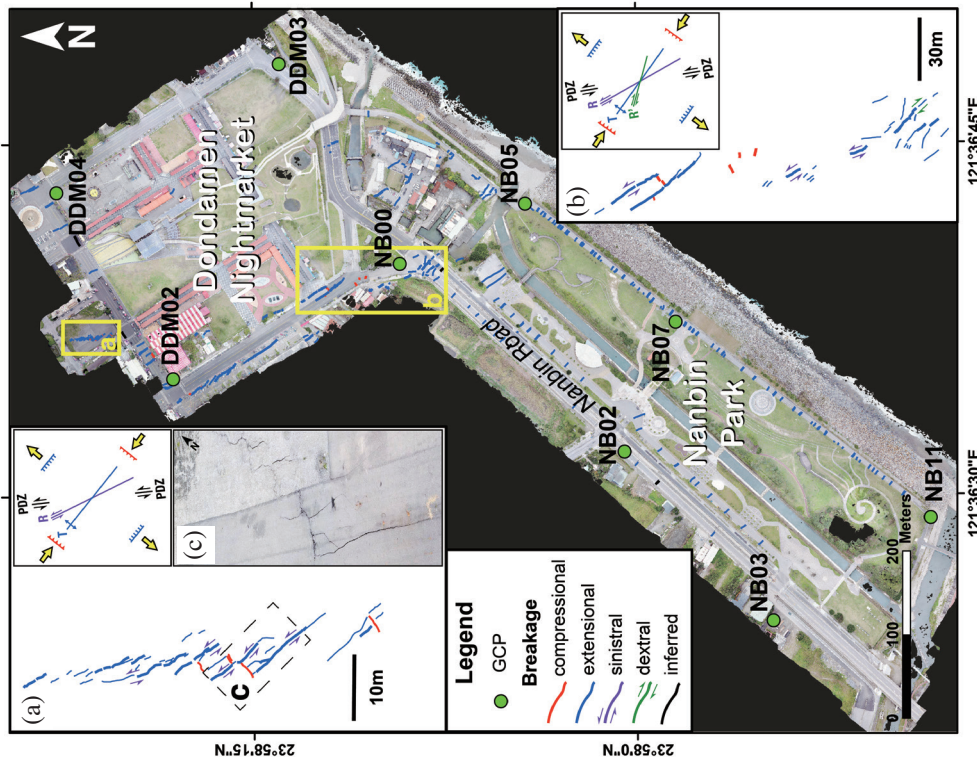
Towards southern Hualien City where the surface trace of the Milun fault ends (Fig. 1), surface breakages are concentrated along the western part of the Dondamen Nightmarket and distributed extensively across the whole Nanbin Park. At a tarred field right north of the nightmarket, a series of $N30 - 40^{\circ}W$ striking sinistral fissures connected by $N50^{\circ}E$ striking push-up mole tracks, implying an almost N-S striking PDZ (Figs. 8a and c). South of the tarred field, fractures are located at the western part of the nightmarket and along Ziyou Road. To the southwest of the nightmarket, surface breakages show similar patterns to those at the tarred field with the PDZ strike of $\sim N15^{\circ}W$ (Fig. 8b). Further south, extensive tensional fissures are distributed along Nanbin Road and across Nanbin Park (Fig. 8). The northernmost fissure ($\sim N25^{\circ}W$) along the bicycle route at the eastern side of Nanbin Park is the largest one with extension of several tens of centimeters. This fissure seems to align with the fracture sets in Figs. 8a and b, denoting a likely curved trace of the PDZ.

Fig. 8. Mapping of surface breakages in southern Hualien City. (a) Detailed mapping of surface fractures on the tarred field north of the Dongdamen Nightmarket. Inset shows the conceptual setting of the stress field and structure orientations. (b) Detailed mapping of surface fractures on Ziyou Road. Inset shows the conceptual setting of the stress field and structure orientations. (c) Aerial photo showing surface fractures at (a).

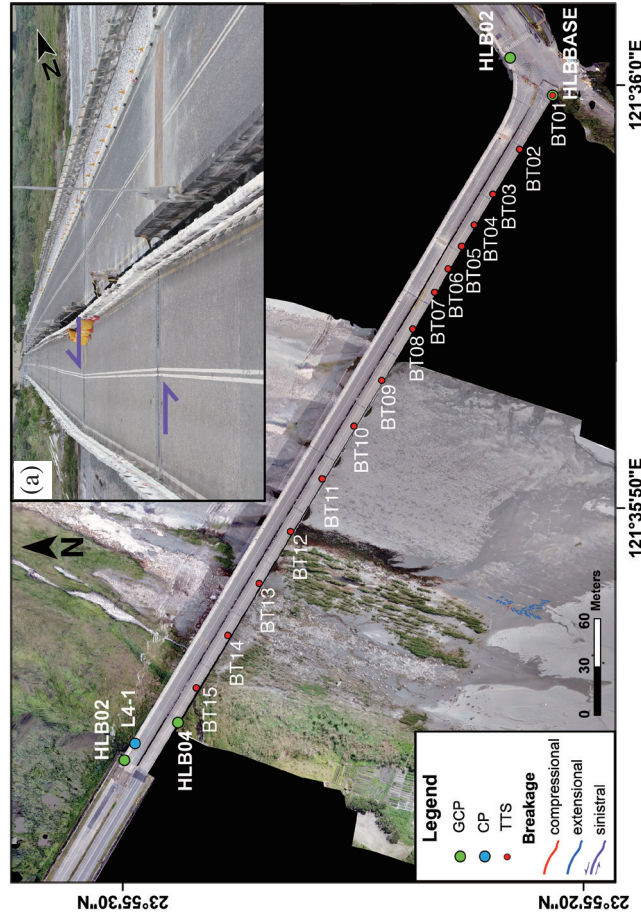
In Hualien River, the surface ruptures offset Hualien Bridge and broke the surface of the western floodplain, suggesting that the northern segment of the Longitudinal Valley fault (Shyu et al. 2016) or Linding fault (CGS 2012) is active during the earthquake. According to our orthoimages and 3D model, the forth bridge segment from the east is offset in a sense of left-lateral strike-slip motion, indicating the fault trace ran below this bridge segment (Fig. 9a). In addition, we measured the amount of sinistral offset by using a Leica TCRA 1201+ R1000 Total Station. We measured along the

Fig. 9. Mapping of surface breakages around Hualien Bridge. Red points are survey locations by using a Total Station. (a) 3D model of Hualien Bridge showing left-lateral offset.

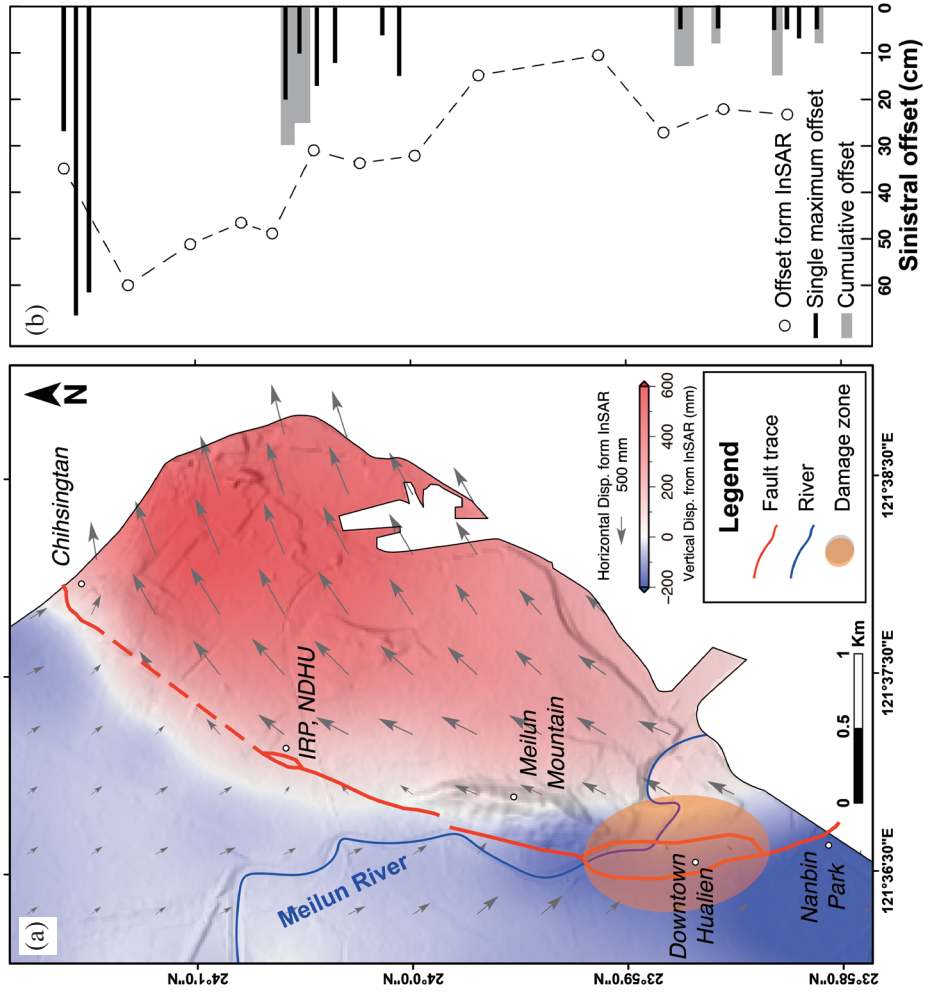
In addition to the orientation changes of the fault trace, amount of slip varies along the strike of the fault. Since we mainly mapped surface fractures based on orthoimages, we estimate along-strike sinistral offsets of single and accumulative fractures (e.g., Angelier et al. 2004) (Fig. 11b). The ruptures in the north show significant sinistral offsets of more than 60 cm and the amount of sinistral slip decreases toward south. It is difficult to estimate slip amount around the areas near Meilun Mountain where surface fractures display compression features or even slightly dextral movements. The ruptures around eastern downtown Hualien is extensively distributed (Fig. 7) so the estimated slip here may be underestimated. In addition, we estimate left-lateral fault slip based on surface displacements derived from InSAR (Yen et al. 2018) for comparison. We compute the differences of the horizontal displacements parallel to the direction of fault strikes across the Milun fault. The comparison indicates that the estimated sinistral fault movements derived from our UAS photogrammetry and InSAR are consistent (Fig. 11b), showing the tendency of large offset to the north and smaller

Fig. 11. Along-strike slip distribution derived from our mapping results. (a) Fault trace of the 2018 Hualien earthquake. Grey vectors are horizontal displacements derived from InSAR and background colors indicate vertical displacement derived from InSAR (Yen et al. 2018). (b) Estimated sinistral offset along the fault. Solid black lines indicate single offset and the thick grey lines indicate cumulative offset of parallel structures. White circles and dashed line are estimated offset from the InSAR result.

offset to the south. For the vertical offset, we only observe obvious uplift along Lane 53 of Chihsing Street. Other compressional features seem to be more like push-up mole tracks (e.g., Fig. 5). The observed uplift feature in Chihsingtan is consistent with preliminary field investigations (CGS 2018; ETEC 2018). Unfortunately, the feature is right in front of local buildings so the 3D model produced by the SfM-MVS method is distorted, making us difficult to estimate vertical offsets directly from the 3D model.

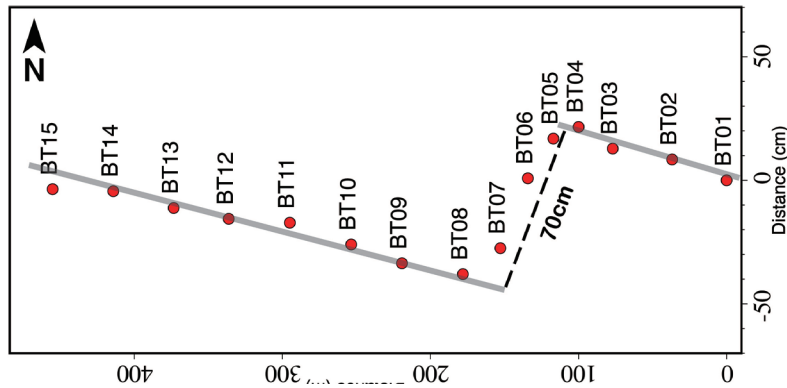
western side line and estimated ~70-cm offset (Fig. 10). In the western floodplain south of the bridge, dense surface breakages are present in a short distance of ~40 m (Fig. 9). This set of breakages seem to be parallel to the Linding fault but out of alignment with the offset bridge segment. Thus, the breakages in the floodplain may not represent the location of the surface trace of the Linding fault.

Fig. 10. Survey results of the total station along Hualien Bridge, showing sinistral offset of ~70 cm. Absolute coordinates are derived from RTK-GPS measurements at BT01.
